Innovation Park  
**Jump Start Collins Building**

SCHEMATIC DESIGN STUDY | CO-WORKING/FAB LAB FACILITY FOR START-UP BUSINESSES | 5.25. 2017

Existing Structural Conditions Photo Essay

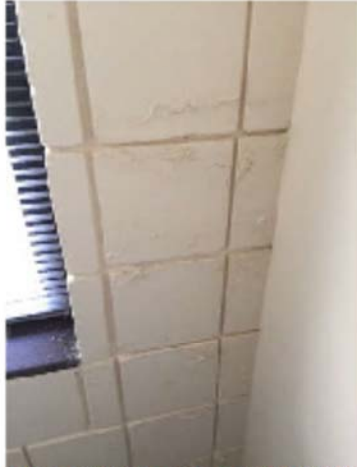
1. Roof leaks were observed at random locations around the perimeter of the building which are resulting in damage to the ceiling finishes. It may be possible some of this moisture is coming through the walls as well. There were no signs that this moisture is doing substantial damage to the structure.
2. The building soffits are damaged in several locations consisting of light corrosion or missing/disconnected soffit panels and closure strips.
3. Oxidation of the exterior steel doors on the south side of the building.
4. Leaves clogging the gutters and downspouts.
5. Trees originally placed close to the building have matured and are growing into the building structure. This will result in wear on the exterior finishes.

Moisture damage on interior of building

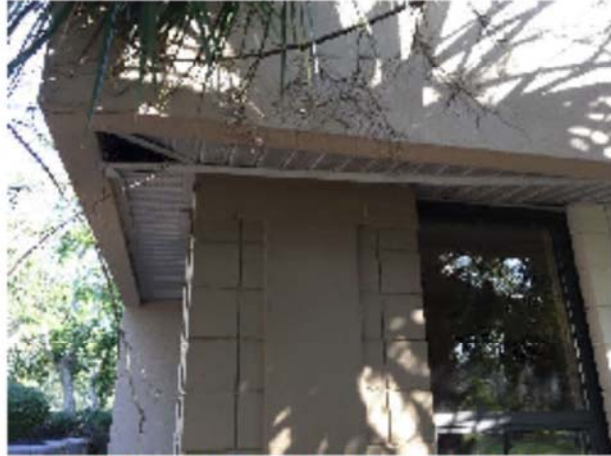
Typical damage to soffits in southwest building corner

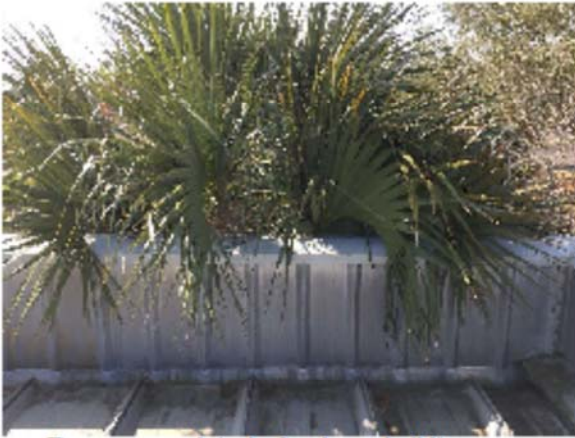
Tree overgrowth in the Southwest building corner

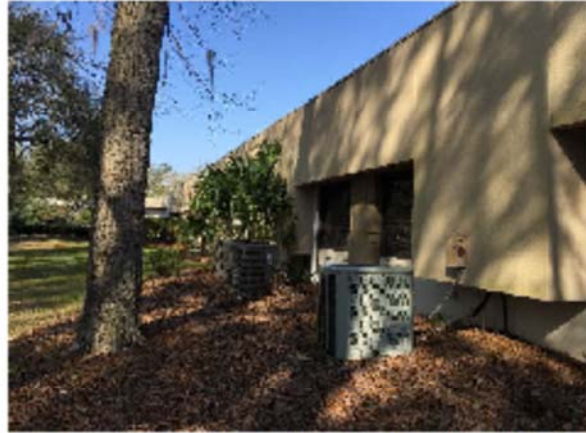
Trees growing into the exterior walls on southern elevation

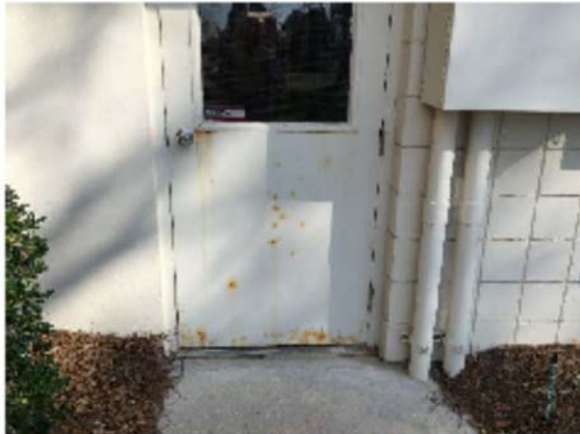
Fenestrations consist of insulated aluminum windows and a combination of hollow metal and aluminum storefront entrance doors. Windows are in fair condition throughout the building and do not appear to be leaking or fogged. All fenestrations appear to be intact and useful in their current condition, though some oxidation was observed on both frames and panels.

Oxidation of exterior steel doors on the South elevation

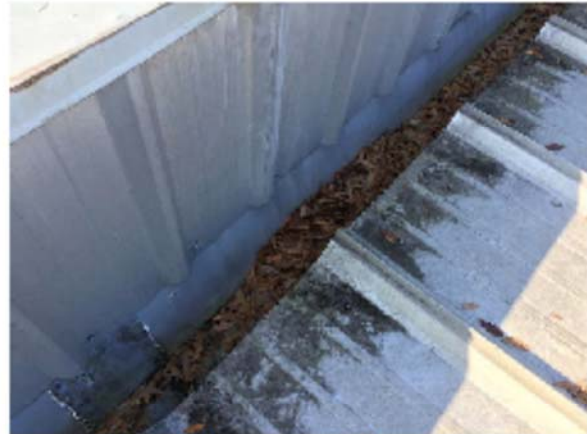
Leaves filling gutters and downspouts

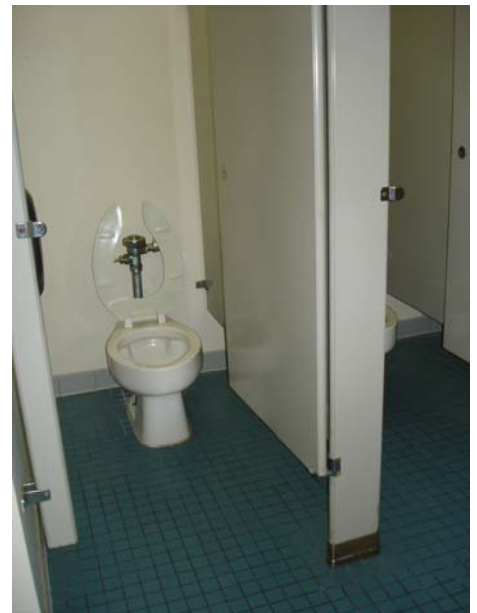
Existing Restroom

The existing bathrooms require modification to meet current accessibility standards. There are no bathroom stalls that are large enough to provide the required turning radius in addition to missing a handicap accessible sink. To alleviate the deficiency in accessible stalls it could require relocation of toilets, adding handicap accessible lavatories, and reconfiguring various stall partitions in addition to cropping a portion of exiting countertop. New finishes and fully accessible fixtures and accessories in addition to all new flooring in the restrooms should be replaced as part of the renovation.

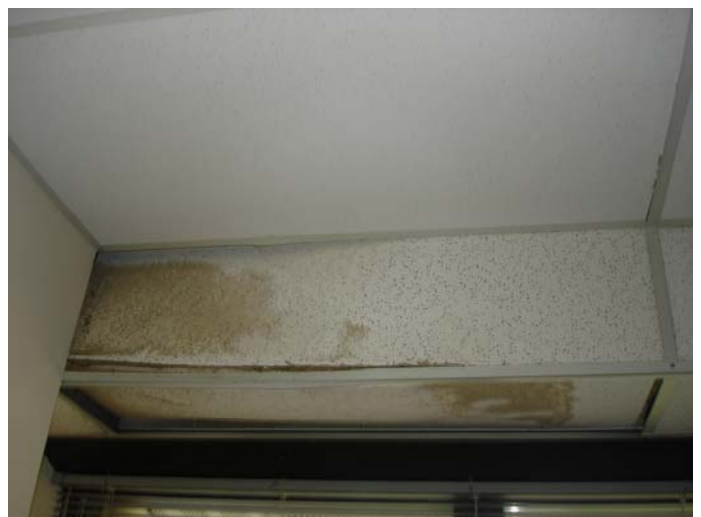
Existing Water Damage
