Innovation Park  
**Jump Start Collins Building**

SCHEMATIC DESIGN STUDY | CO-WORKING/FAB LAB FACILITY FOR START-UP BUSINESSES | 5.25. 2017

Existing Structural Conditions Photo Essay

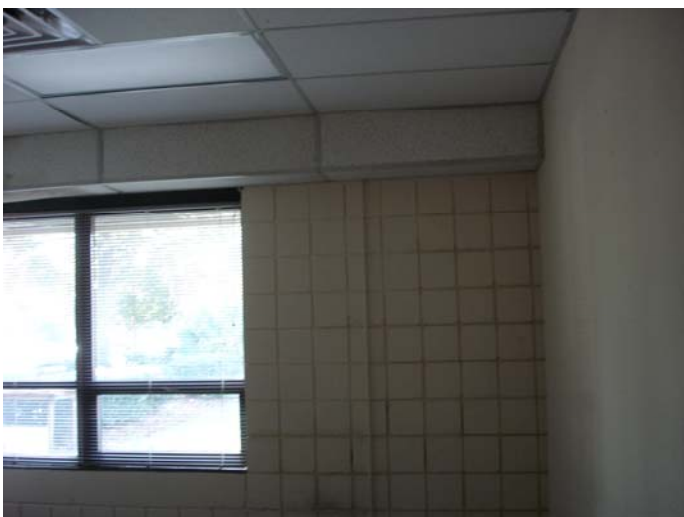
Fenestrations consist of insulated aluminum windows and a combination of hollow metal and aluminum storefront entrance doors. Windows are in fair condition throughout the building and do not appear to be leaking or fogged. All fenestrations appear to be intact and useful in their current condition, though some oxidation was observed on both frames and panels.

Block Wall and Typical Fenestration
